Compacted Greenspace and Stormwater Hydrology in Burlington, Vermont:  
An analysis of 3 remediation treatments for compacted soils and a comparison  
of stormwater from two small urban catchments.

A Thesis Presented  
By  
Nathan Arun Toké  
To  
The Honors Committee of  
The University of Vermont

As partial fulfillment of a Bachelor of Science in Geology  
Through the Department of Geology of  
The University of Vermont

May, 2003

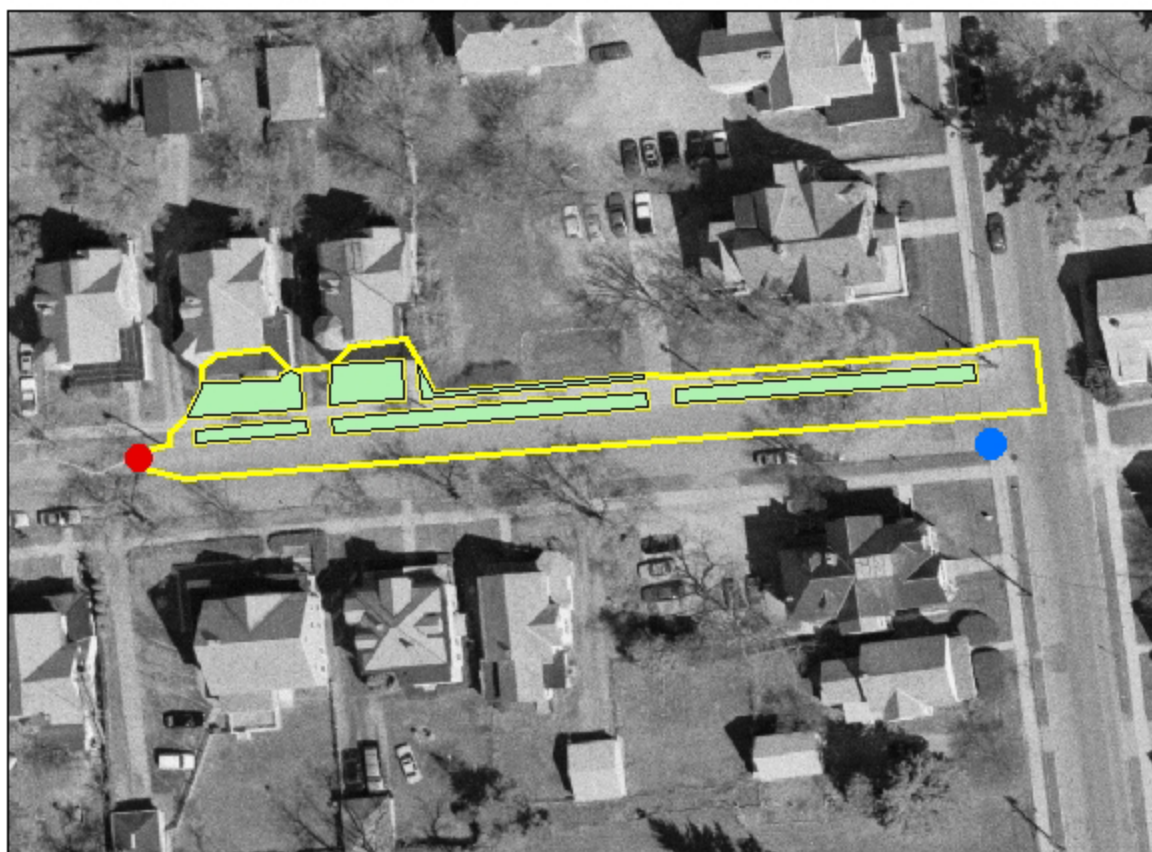
**Figure 1.2: Brookes Avenue land cover and drainage basin delineation**

Brookes Avenue Drainage Basin is 920 square meters. It is composed primarily of impermeable surfaces including the Brookes Avenue roadway, sidewalk, driveways, and portions of some buildings. There are 6 areas of greenspace covering 25% of the basin (Table 1.1).

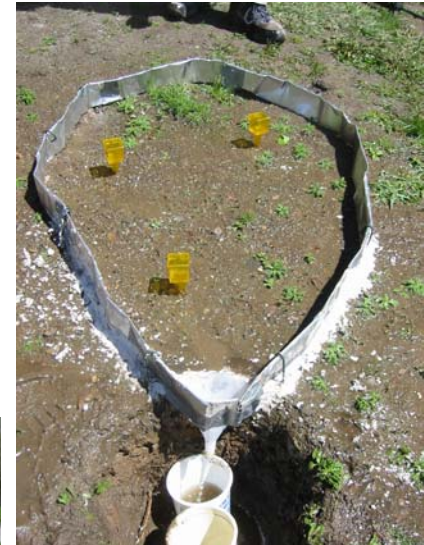
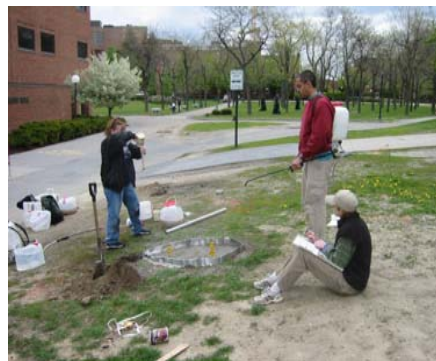
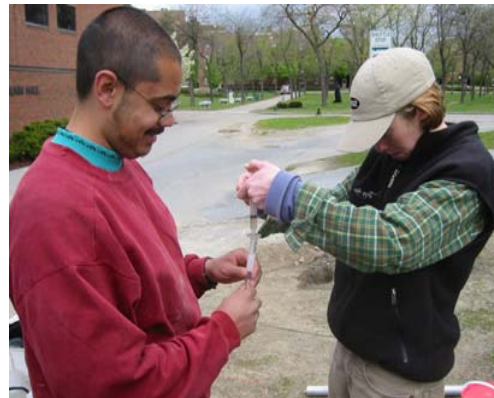
Figure 2.3: Simulated rainfall test: infiltration rate analysis, runoff collection, dissolved load chemical sampling, and measurement of suspended sediment.

Construction of the tear drop Rainfall simulation apparatus.

Area measurement

Rain gauges and Runoff collection

Runoff measurement

Before any remediation was conducted, each of the four compacted sites was tested for pre-remediation parameters during the third week in May 2002. Megan McGee, (2003), studied the parameters of soil density and infiltration capacity. To obtain a steady-state infiltration rate, we used the rainfall simulation method previously employed by Mellilo et al. (2002) and Persico et al. (2002). The infiltration tests involved constructing a tear-drop-shaped test area, such that the narrow part pointed down slope (Figure 2.3). Aluminum sidewalls were pushed into the ground and sealed on the outside of the structure with plaster. Three rain gauges were placed within the measured test plot area. At the test plot outflow, an aluminum collection plate was emplaced, leading to a funnel which allowed the water to flow into a collection bucket located in a previously dug hole. Rainfall was simulated using one to two backpack sprayers. Rainfall amounts were recorded in centimeters, runoff was collected and measured, and corresponding time intervals were recorded. The infiltration tests were conducted until it appeared that a steady state infiltration rate had been obtained (the same amount of runoff was produced over the same time interval).

From each of the infiltration tests, I collected all of the runoff produced. From the cumulative runoff, I obtained one 15mL water sample for each test conducted. I did this by mixing the 5-gallon water bag and then drawing the sample through a 0.2-micron filter into a 15mL sample bottle. I then added 2 drops of 5% nitric acid and stored the sample for later ICP analysis. A blank was obtained from the rainfall simulation backpacks; however, this blank was acidified without filtration rendering it unusable for dissolved

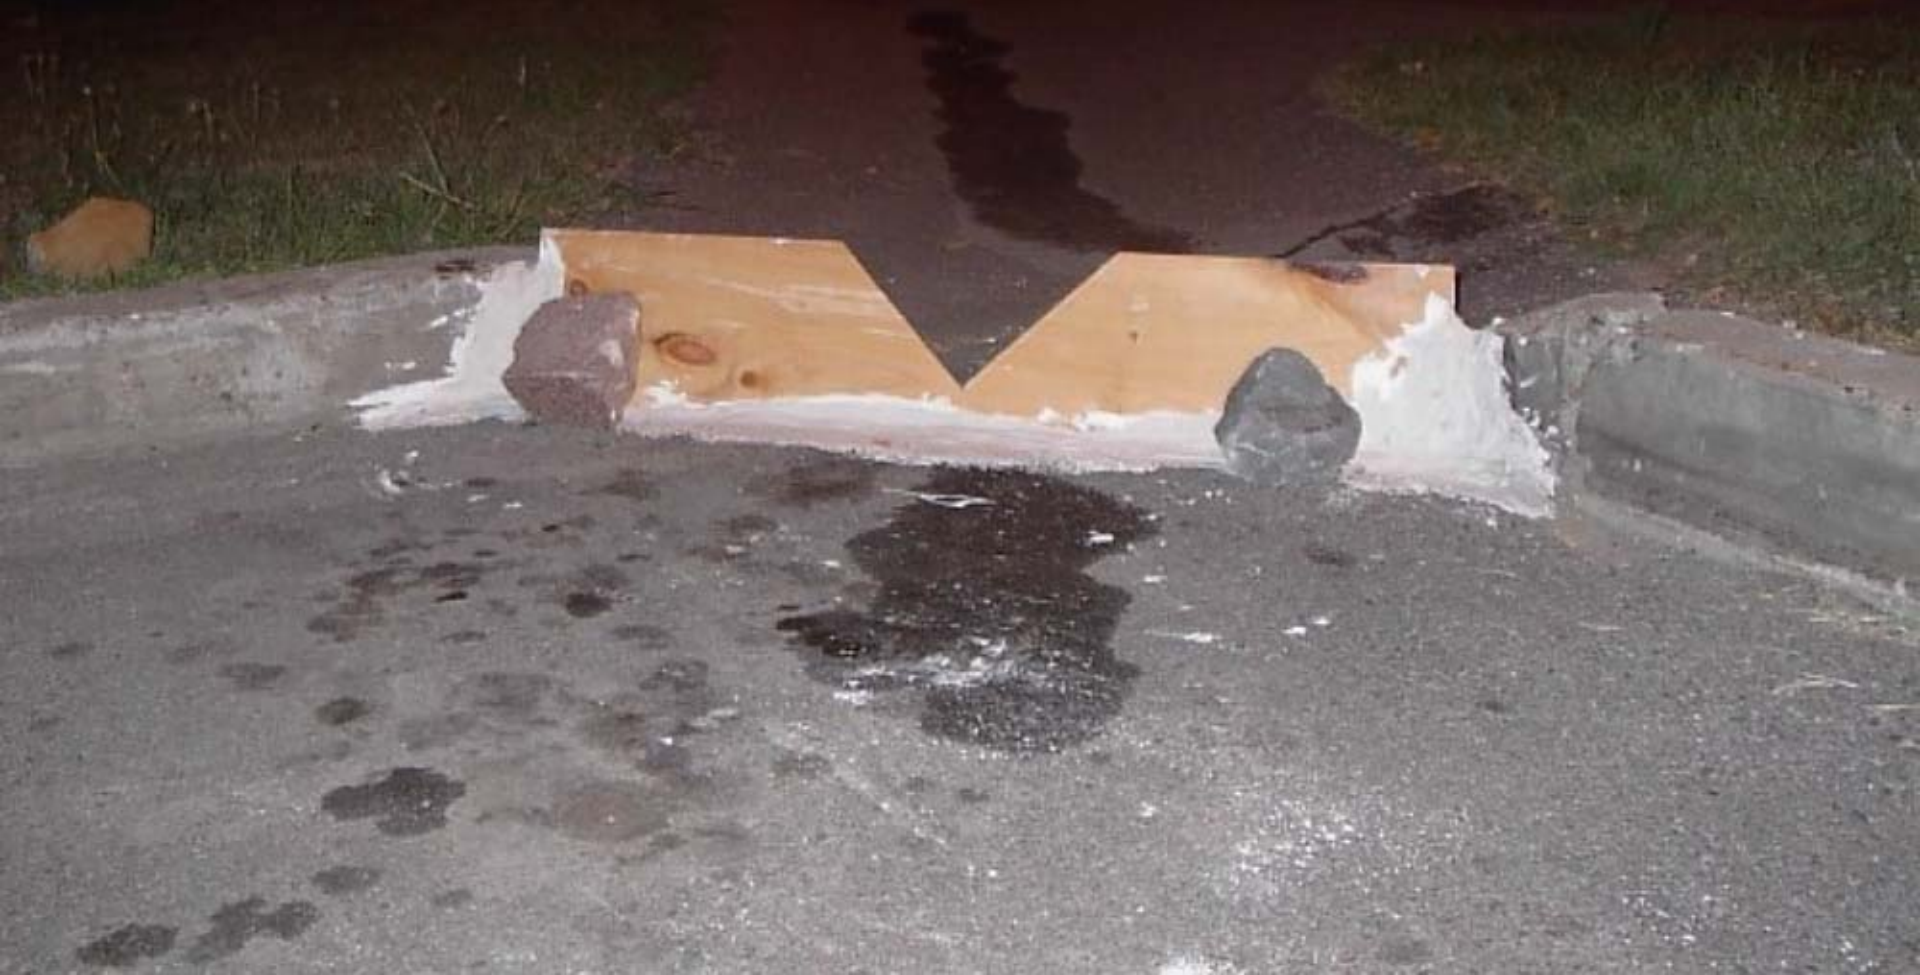
Figure 2.4

The Perkins Parking Lot Weir Constructed on Sept 10<sup>th</sup>, 2002. The V-notch is 90 degrees and is tapered to a shear edge. The weir is held in place with the existing curb, a plaster seal, and rocks. Note that there are clear automotive fluid stains on the pavement

I constructed several temporary wooden weirs following the installation guidelines given on the v- notch (triangular) weir calculator webpage (<http://www.lmnoeng.com/Weirs/vweir.htm>). The guidelines were followed as closely as possible, but with several replacement weirs necessary because of destruction by angry or inconsiderate drivers; some variations in weir geometry undoubtedly occurred. Weirs were emplaced using existing curbing as the primary support along with cinder blocks, large rocks, and plaster to create a seal along the base and sides of the weir (Figure 2.3).

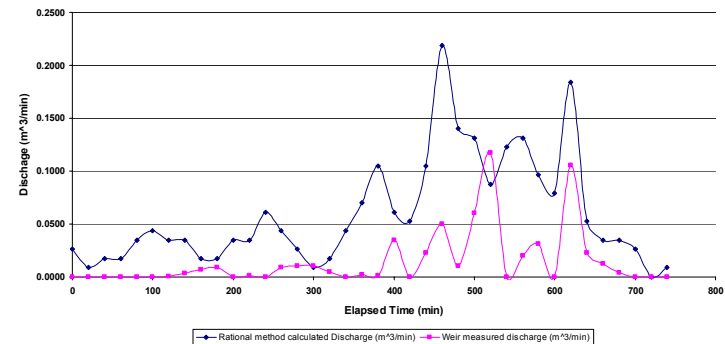
Brookes 9/27/02 Rational method calculated hydrograph (shifted 60 minutes to observed peak discharge) and weir measured discharge
